**State of Louisiana  
Coastal Protection and Restoration Authority**

**2015 Annual Inspection Report**

**HOPEDALE HYDROLOGIC  
RESTORATION (PO-24)**

August 10, 2015  
St. Bernard Parish

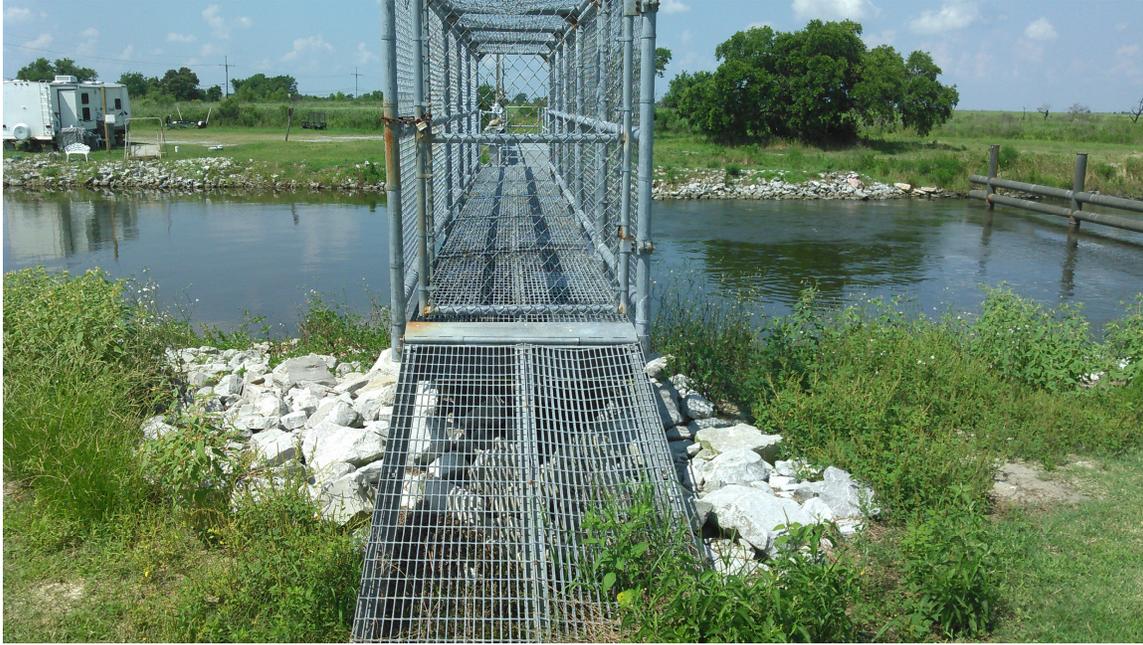
**Photograph #1 – Water Control Structure**

Hurricane Isaac passed through Southeast Louisiana on August 28, 2012. The only damage noted on this structure was a damaged stem cover on one of the Fish Gates.

- Replace one vinyl gate stem cover.

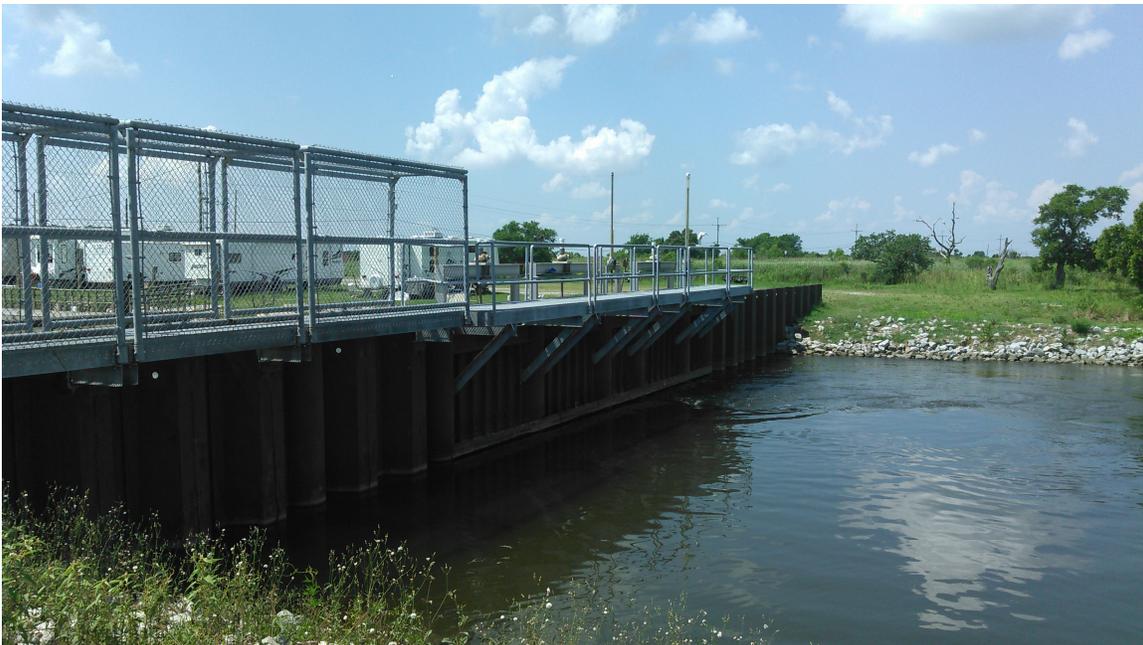
**Photograph #2 – Water Control Structure**

The fish gates were open at the time of the inspection in accordance with the Operation and Maintenance Plan. Lake Borgne Basin Levee District personnel performed the first round of operations and routine maintenance on September 27, 2011. There have been no operations activities since due to personnel issues. This Contract has expired and CPRA is currently trying to get a new Operations Contract in place. The gates were hand cranked at the inspection to determine functionality and were determined to be in working order. No other issues present at the time of inspection.
